Padmount PMH Switchgear Condition Assessment

Seattle City Light
WORK PRACTICE
Padmount PMH Switchgear Condition Assessment

Standard Number: 1167.19

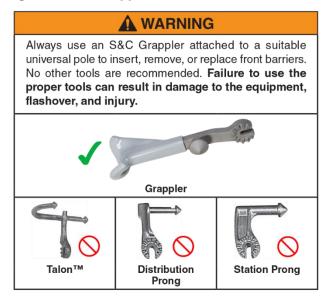
Figure 4. S&C Grappler

Always use an S&C Grappler attached to a suitable universal pole to insert, remove, or replace front barriers. See Figure 4. No other tools are recommended. Failure to use the proper tools can result in damage to the equipment, flashover, and injury. An S&C Grappler should be located next to the storage rack on the interior fuse compartment door of each unit.

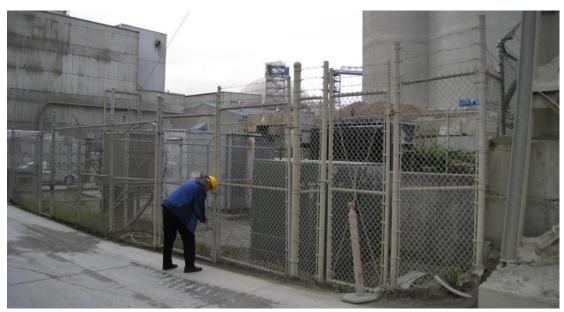
1a. Switch located inside customer's substation as shown.

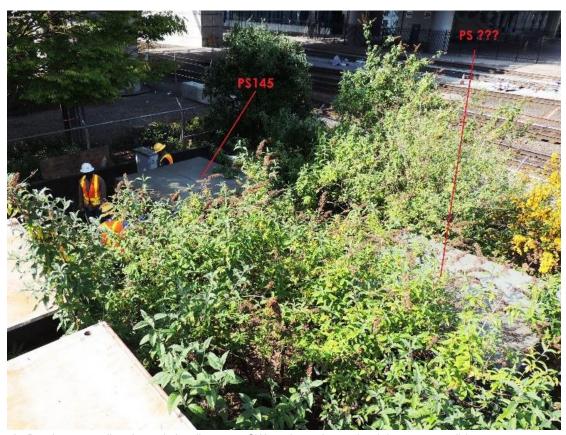
1b. Brush surrounding the switch adjacent to SW648 is so dense that it is not accessible.

Assessment	Performance Expectations	image Reference
Access to site	 Switch is reasonably accessible to SCL operations and maintenance personnel. Accessing the site does not require a special key, permit, or prior approval for entry, as may be required for locations inside a customer building or facility. 	1a
Compartment access	 Compartments are accessible with adequate space to perform routine operations and maintenance: 10 ft in front of doors, 3 ft on sides. 	1b, 1c

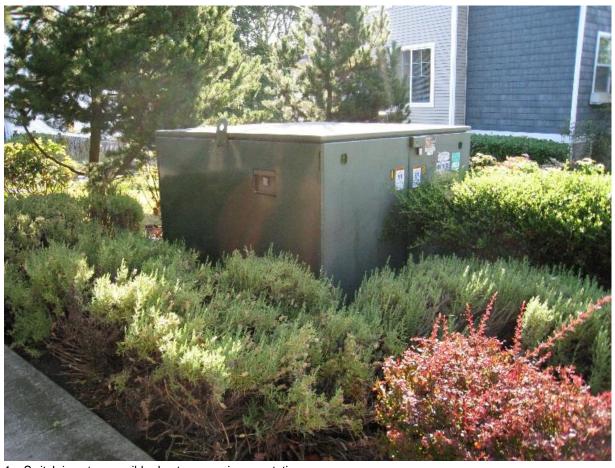
1c. Switch is not accessible due to excessive vegetation.

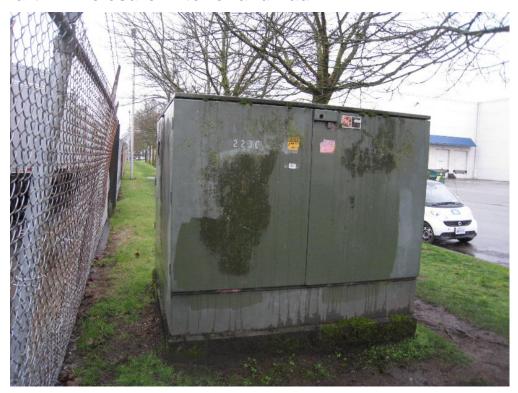
2a. Switch is missing danger and warning signs. The existing caution signs are outdated and damaged.

Assessment	Performance Expectations	Image Reference
Signs and labels	 Warning, danger, and notice signs are easy to read. Switch (SOC) Nur and Equipment (PS) numbers are assigned and easy to read. See SC Work Practice 1167.13 for padmount switch signs and labels. 	
Paint condition	No graffiti, only minor rust, no moss	2b
Pad	 No major cracks, reasonably level 	_
Seal	Enclosure sealed at pad to prevent animal ingress	_
Doors, locks, and latches	 Easy to operate, proper alignment, all latch points engage, locks and F head holts are secure 	Penta –

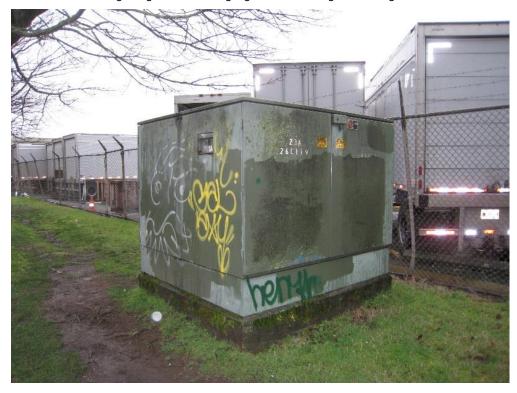
2b. Switch surface is covered with excessive moss and graffiti.

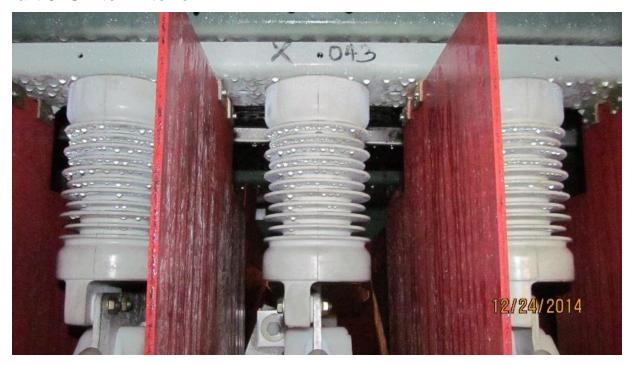
3a. Excessive condensation build up on the insulators and interior of the switch.

Assessment	Performance Expectations	lmage Reference
Water ingress	No standing water	3a
Conduits	Sealed	3a
Vapor barrier	Installed	3a
Condensation	 Little or no condensation on roof or walls 	3b
Contamination	Little or no contamination on room or walls.No signs of animal intrusion	-

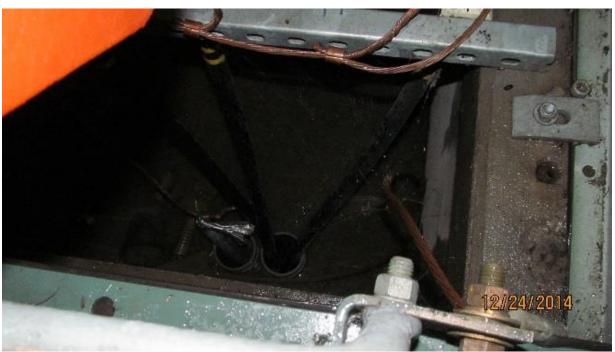
3b. Conduits are not sealed and a vapor barrier is not installed.

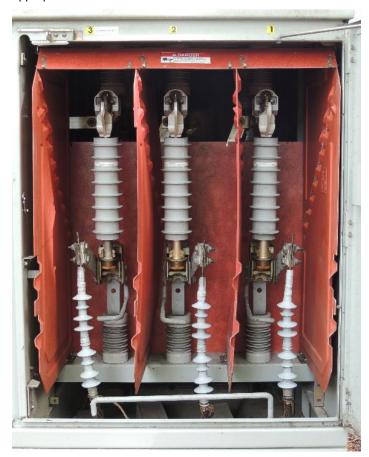
5b. Barrier boards at the center are bent.

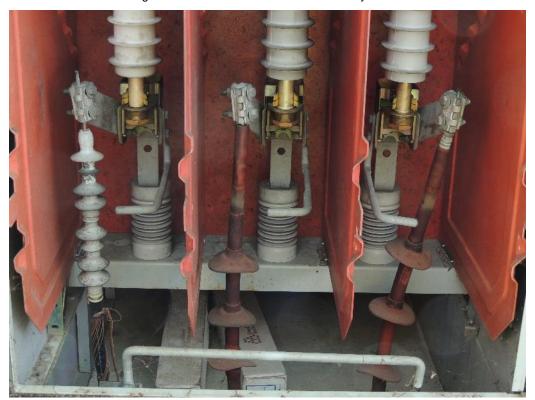
6b. Two terminations on the right side appear to be an older vintage. The termination skirts on the left termination extend far below the ground studs. The alignment of the termination skirts and the ground studs should be similar to one shown in photo 7.

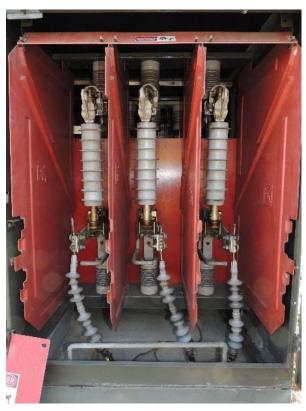
6c. Two terminations on the far left are bent and are pulling on the terminal pads. The termination on the right appears to be touching the concrete pad. The terminal pads are in the Standard position.

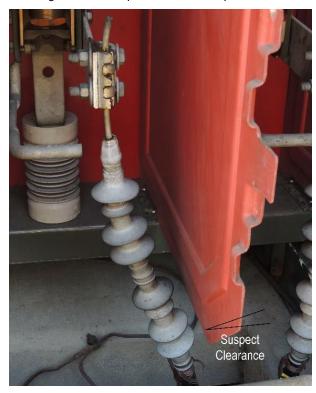
6d. Termination is too close to the barrier board.

Assessment	Performance Expectations	Image Reference
Terminations	 Only minor contamination, no signs of corona damage, no signs of tracking on surface 	
Installation	 Terminations of the same compartment are of the same style/type. Terminations are straight and do not touch concrete knockouts. Cables are not pulling on terminations. Termination top skirt is below or at the same level as the ground studs. 	6b, 6c
Electrical clearances	 There is at least 6-1/2-in of clearance from the grounding studs to the concentric neutral cable at the base. The clearance of the terminator skirts to the barrier board meets the 1-1/4-in minimum air clearance requirements as described in Table 3 of S&C Data Bulletin 662-590. 	6d, 6e

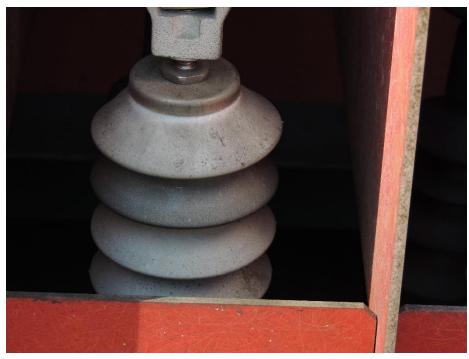
8. Surge arrester shows signs of contamination.

Assessment	Performance Expectations	Image Reference
Surge arresters	Little to no surface contamination	8a
	No signs of physical damage	
Electrical clearances	Clearance from the surge arrester connecting rod to the barrier board, to termination skirts, or to the insulating surfaces between the concentric neutral's end and the conductor lug should be at least 2-1/4 inches for 25 kV as described in Table 3 of S&C Data Bulletin 662-590.	4e

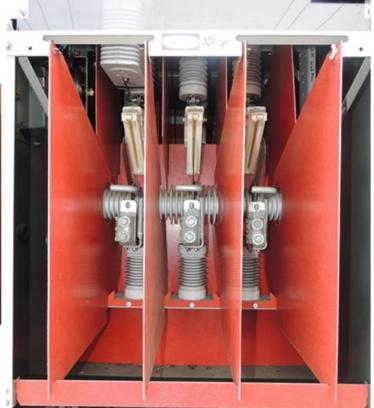
10b. Pre-2005 PMH Switch strut assembly. Note that the strut assembly runs the full length of the switch and is attached to the switch frame on both ends.

- Pre-2005 Design: In this design version, the strut assembly runs the full length of the switch compartment and it is attached to the switch frame on both ends. With the exception of arc compressors, if something goes wrong with the switch, S&C will provide a new switch that would fit inside the existing switch compartment. (See Image Reference 10b)
- Post-2005 Design: In this design version, the strut assembly does not run the full length of the switch. Instead, it is attached to the switch frame on one side and supported by the lower switch insulators on the other side. The switch inter-phase and end barrier boards are also different in the post-2005 design. (See Image Reference 10c)
