Encountering Non-Compliant Installations of Communications Attachments in the Field

This work practice provides direction on the steps to take when non-compliant installations of communications attachments are encountered in the field.

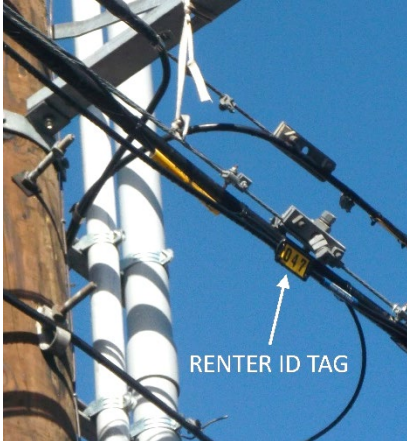
Steps	Description	Example
Step 4	Take a close-up photo of a 3-digit renter identification (ID) tag. ID tags are required to be applied by the organization/renter of such equipment at every location to which the equipment is attached including all cables, risers, handholes, equipment boxes, etc. See SCL 0093.12.

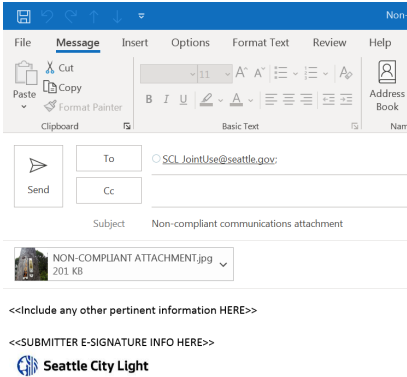
Step 5	Email photos to Joint Use at SCL_JointUse@seattle.gov . Include in the header of the email the phrase, “Non-compliant communications attachment”. In the body of the email, include any other pertinent information as submitter sees fit, such as the specific location of the attachment(s) on the pole.
