Overhead Transformer Lightning Strike Procedure

1. Scope

This standard covers the decisions operations personnel make when an overhead transformer installed in the field is out of service and a lightning strike is the suspected cause.

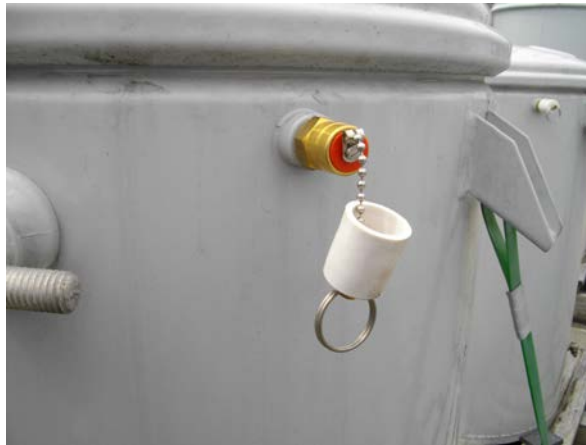
Figure 4.1. Transformer Pressure Relief Valve, Activated

- Has the pressure relief valve (PRV) activated? See Figure 4.1. An activated PRV (cap hanging, red target exposed) could indicate that an event took place within the transformer and it subsequently ejected gas to the atmosphere in order to prevent a tank explosion.
- Are there signs of lightning activity including black char on the tank or oil leakage?

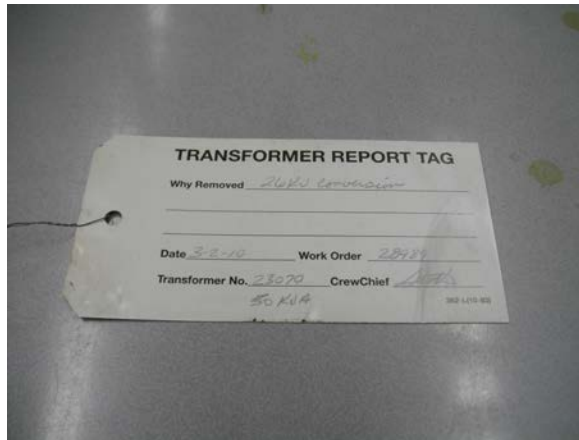
Figure 4.2. Transformer Report Tag

The suspect transformer shall be taken to the Transformer Repair Shop at the South Service Center for testing. The Crew Chief shall fill out and attach the Transformer Report Tag describing why the unit was removed, the date, and other relevant information. See Figure 4.2.
